## Series 1000 and 1500

## 23. TRACTION DRIVE BELT REPLACEMENT: HYDROSTATIC LT

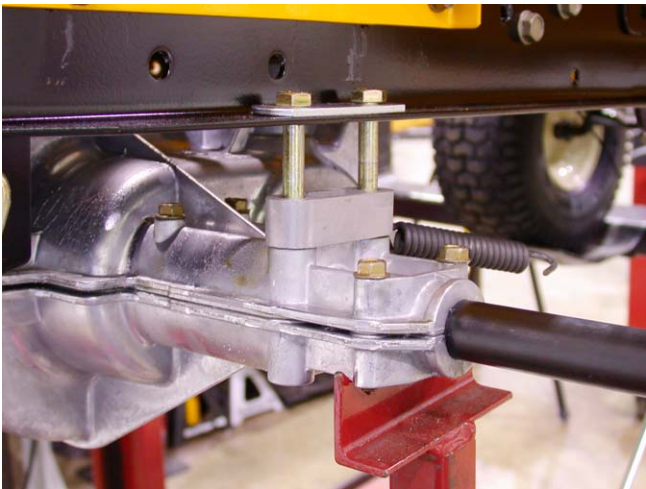
**Figure 21.13**

21.13. Lower the transmission from the rider. See Figure 21.13.

**NOTE:** There is a backing plate on the top of the frame. There may be a spacer between the frame and the transmission housing.

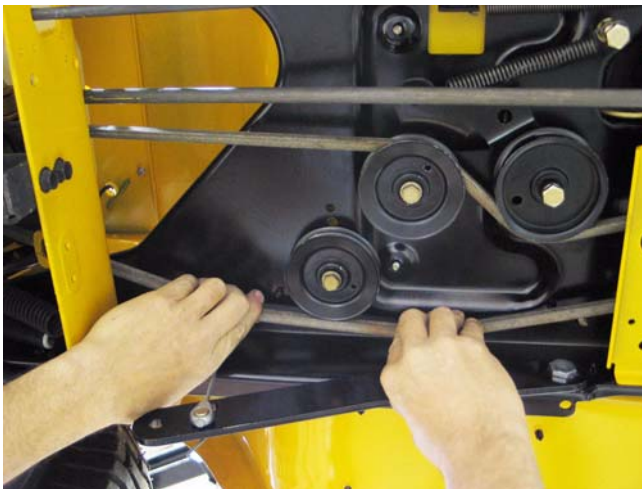
**Figure 23.5**

- Spacers above or below the traction drive pulley.
  - Integral or separate key on traction drive pulley.
  - Different PTO clutch anti-rotation brackets.
- 23.5. Slip the belt off of the single fixed idler. See Figure 23.5.

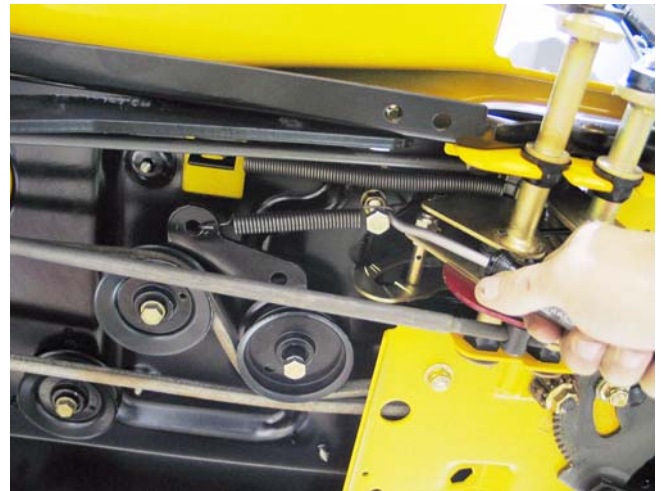
**Figure 23.6**

- 23.6. Carefully release the spring that maintains tension on the double idler bracket using a length of starter rope or an appropriate tool. See Figure 23.6.

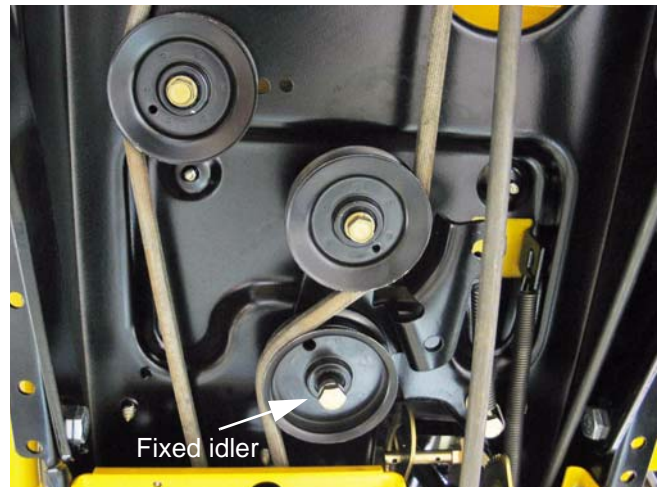
**Figure 23.12**

23.12. The fixed idler pulley can be removed from later models using a single 1/2" wrench. The bolt that holds the fixed idler to earlier models threads into a 3/8" nut above the tractor frame. The bolt can be removed from the nut using a pair of 9/16" wrenches without removing the fenders. See Figure 23.12.
