Series 1000 and 1500

30. TRACTION DRIVE BELT REPLACEMENT: HYDROSTATIC GT

31. DRIVE SYSTEM ADJUSTMENT: HYDROSTATIC GT

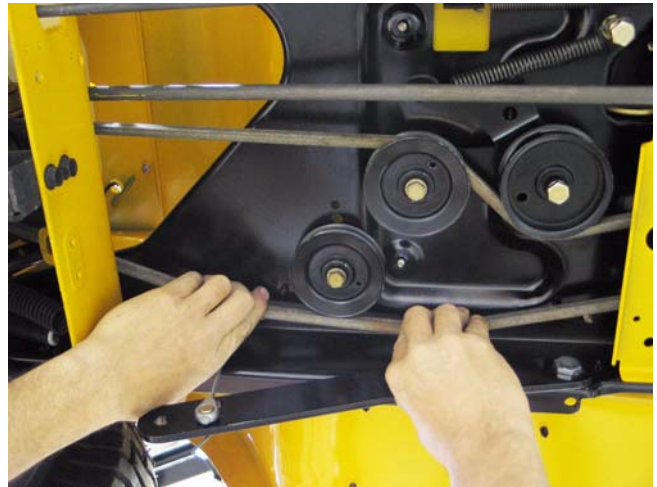
Figure 30.5

- 30.5. Slip the belt off of the single fixed idler. See Figure 30.5.

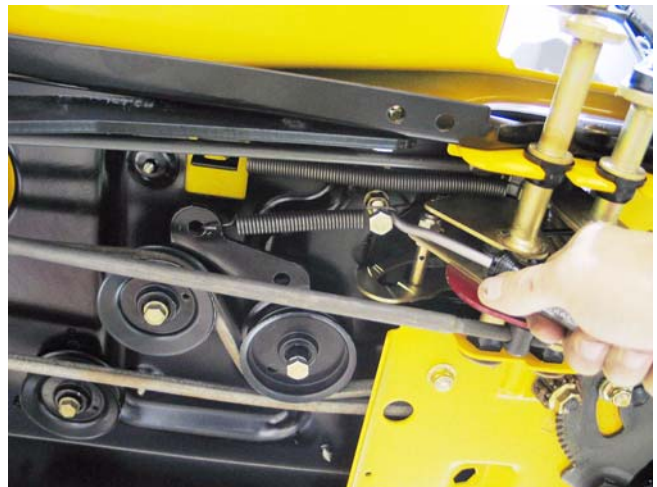
Figure 30.6

- 30.6. Carefully release the spring that maintains tension on the double idler bracket using a length of starter rope or an appropriate tool. See Figure 30.6.

- 30.7. Slip the drive belt from between the double idler pulleys.

NOTE: On some early models, the rear-most pulley (rides against V side of belt) was large enough that the double idler bracket acted as a belt keeper. On those models, it is necessary to loosen the nut and bolt that secure that pulley to the bracket in order to slip the belt past the edge of the bracket.

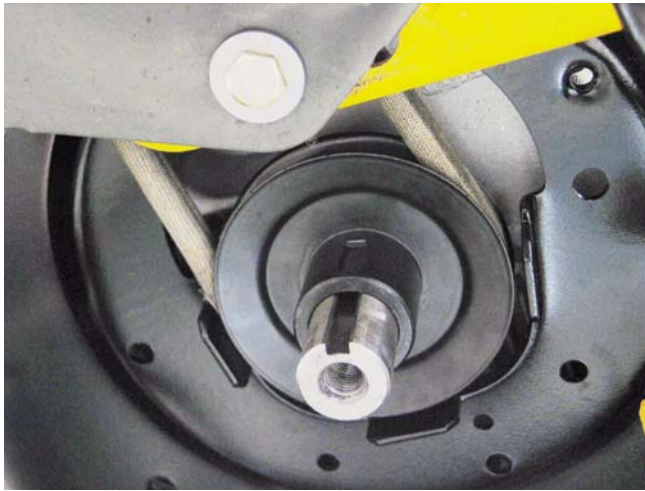
Figure 30.8

30.8. Slip the crankshaft pulley down far enough to get the belt off of the pulley, and remove the belt from the crankshaft. See Figure 30.8.

NOTE: Belt keepers that are part of the tractor frame prevent the belt from being removed without lowering the pulley.

NOTE: The pulley may be removed from the crankshaft at the discretion of the technician.

- If there is a spacer above the pulley, the end with the radiused inside edge mates with the radiused step on the crankshaft.
- If one end of the pulley has a radiused inside edge, that is the end that mates with the radiused step on the crankshaft.
